DEPARTMENT OF TRANSPORTATION**DIVISION OF ENGINEERING SERVICES**

Contract #: 04-0120F4Cty: SF/ALA Rte: 80 PM: 13.2/13.9File #: 69.28**WELDING INSPECTION REPORT****Resident Engineer:**Siegenthaler, Peter**Address:** 333 Burma Road**City:** Oakland, CA 94607**Report No:** WIR-022257**Date Inspected:** 28-Mar-2011**Project Name:** SAS Superstructure**OSM Arrival Time:** 700**Prime Contractor:** American Bridge/Fluor Enterprises, a JV**OSM Departure Time:** 1900**Contractor:** Zhenhua Port Machinery Company, Ltd (ZPMC), Changxing Island **Location:** Shanghai, China**CWI Name:** Zhu Zhong Hai**CWI Present:** Yes No**Inspected CWI report:** Yes No N/A**Rod Oven in Use:** Yes No N/A**Electrode to specification:** Yes No N/A**Weld Procedures Followed:** Yes No N/A**Qualified Welders:** Yes No N/A**Verified Joint Fit-up:** Yes No N/A**Approved Drawings:** Yes No N/A**Approved WPS:** Yes No N/A**Delayed / Cancelled:** Yes No N/A**Bridge No:** 34-0006**Component:** Orthotropic Box Girder(OBG)**Summary of Items Observed:**

Segment 12BE

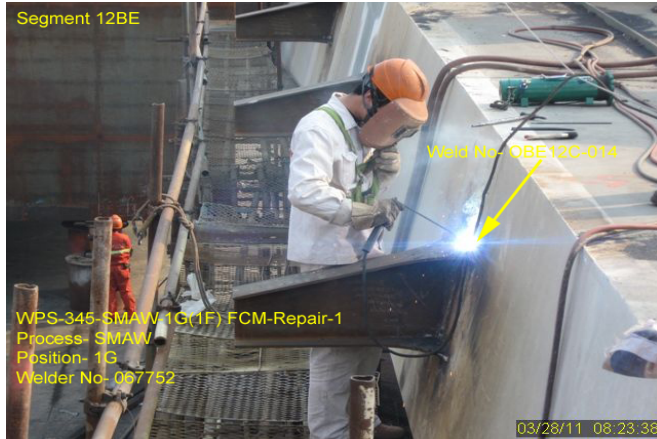
This QA Inspector observed ZPMC qualified welding personnel identified as 067752 perform Shielded Metal Arc Welding (SMAW), weld joint identified as OBE12C-014; located On Orthotropic Box Girder (OBG) Edge Plate to Cantilever Bracket CJP Weld; ZPMC Quality Control (QC) is identified as Mr. Zhou Peng. This QA Inspector observed the base material appears to have been preheated by a torch prior to welding. The Critical Welding Repair Report (WRR) was B-WR20511. ZPMC Quality Control (QC) Mr. Zhou Peng was onsite monitoring the welding variables. The welding variables recorded by QC appeared to comply with applicable WPS-345-SMAW-1G (1F) FCM-Repair-1. See attached photo for further details.

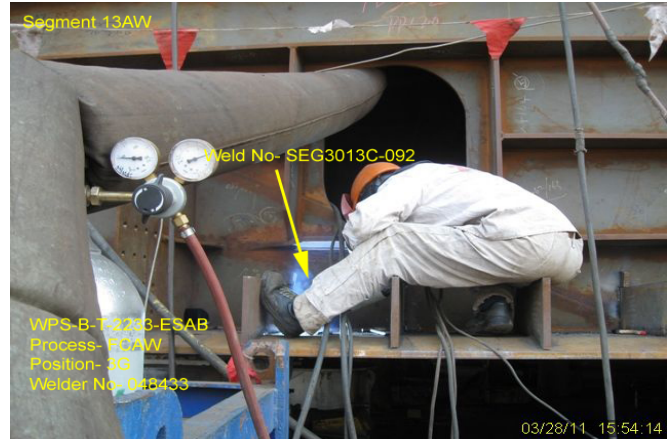
This QA Inspector observed ZPMC qualified welding personnel identified as 048433 perform Flux Cored Arc Welding (FCAW), weld joint identified as SEG3013C-092; located On Orthotropic Box Girder (OBG) Floor Beam to Bottom Plate Stiffener CJP Weld; ZPMC Quality Control (QC) is identified as Mr. Zhang Qiang .This QA Inspector observed the base material appears to have been preheated by an electrical heating element prior to welding. ZPMC Quality Control (QC) Mr. Zhang Qiang was onsite monitoring the welding variables. The welding variables recorded by QC appeared to comply with applicable WPS-B-T-2233-ESAB. See attached photo for further details.
